MISCELLANEOUS PAPER S-73-34

CONDITION SURVEY, PEASE AIR FORCE BASE, NEW HAMPSHIRE

May 1973

Conducted by U. S. Army Engineer Waterways Experiment Station
Soils and Pavements Laboratory
Vicksburg, Mississippi

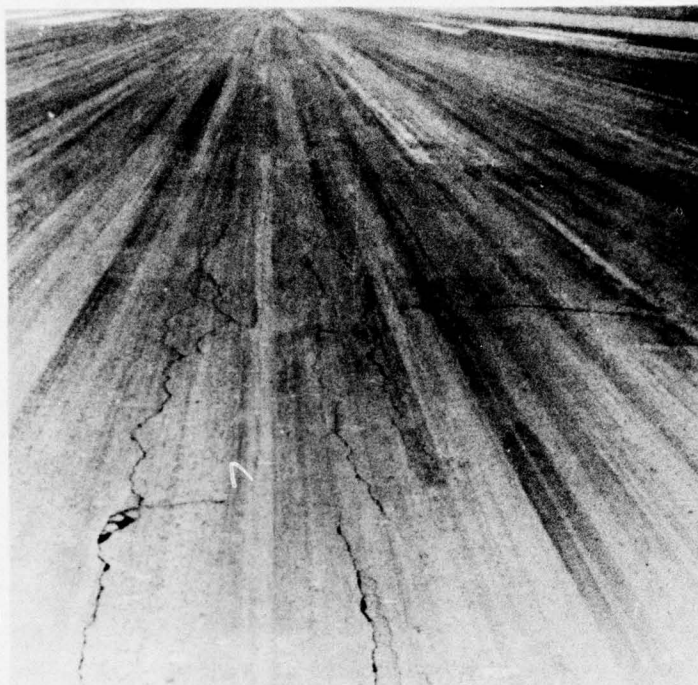
12. The NW end of the runway (features R1A and R2B) was structurally in very good condition based on the percentage of slabs containing no major defects. A total of 26 major defects were noted in feature R1A, all of which were longitudinal cracks. Of the 26 defects, 12 were in the two outer lanes on each side, and the other 14 were about equally divided among the other 8 lanes. Feature R2B contained 46 major defects, 45 longitudinal cracks and 1 transverse crack. Twenty-eight of the defects were located in the two outer lanes on each side; the other 18 were about equally divided among the other eight lanes. The asphaltic concrete (AC) interior portion of the runway (feature R3C) between the 1000-ft portland cement concrete (PCC) ends was in only fair condition because of longitudinal cracking (photos 1 and 2) and slight rutting. (This feature should now be in good condition, since a 3/4-in. friction overlay has been applied.) The SE end of the runway (features R5A and R4B) was in a poor to failed condition based on the number of slabs containing major defects. These two features contained a total of 332 major defects, of which 209 were located in the two outer lanes on each side. Twenty-seven slabs are scheduled for replacement in these features. Photo 3 shows the condition of the PCC pavement at the junction of the AC pavement at the SE end of the runway. The general conditions of the PCC pavements in features R5A and R4B (SE end of the runway) are shown in photos 4 and 5.

Photo 1. General view of cracking on runway approximately
2500 ft from NW end

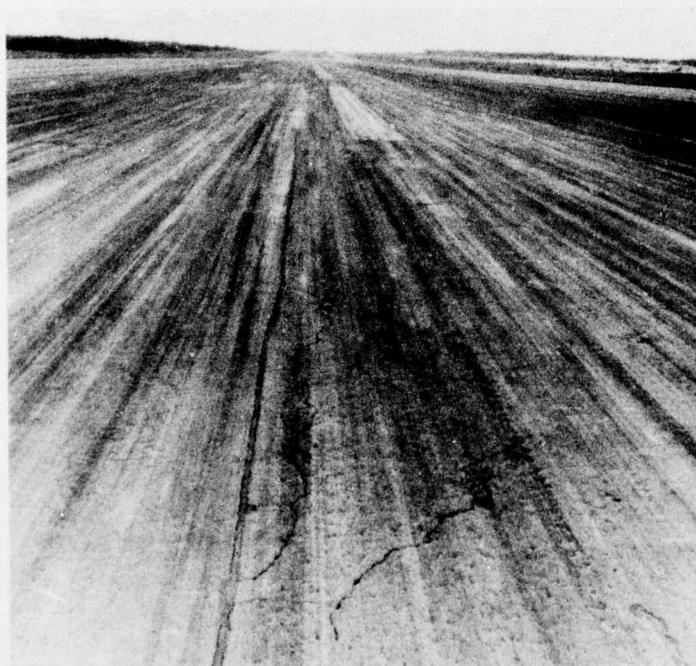
Photo 2. General view of runway near SE end
of AC pavement

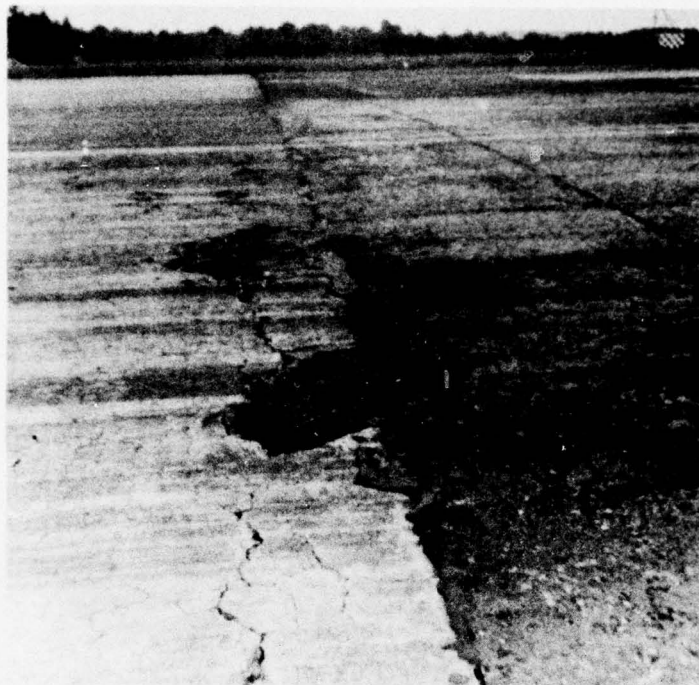
Photo 3. Pavement condition at junction of
PCC and AC at SE end of runway

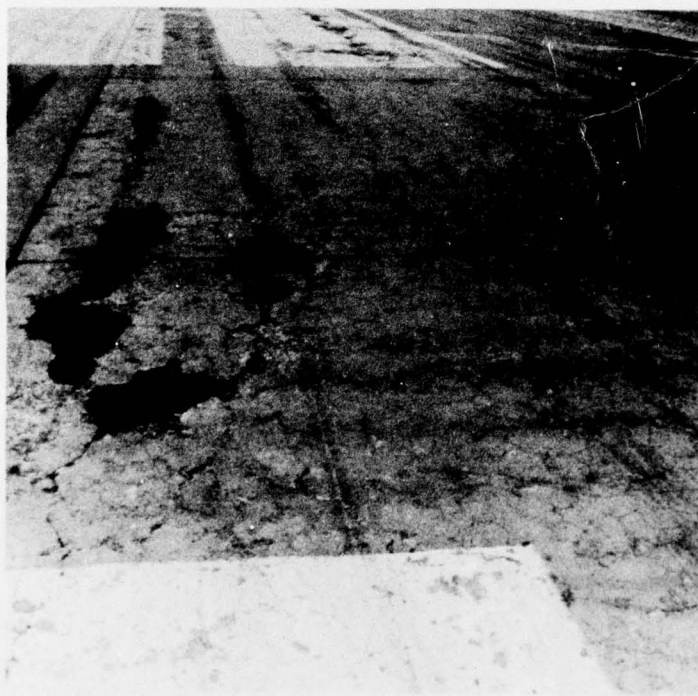
Photo 4. AC surface patches on PCC pavement
at SE end of runway

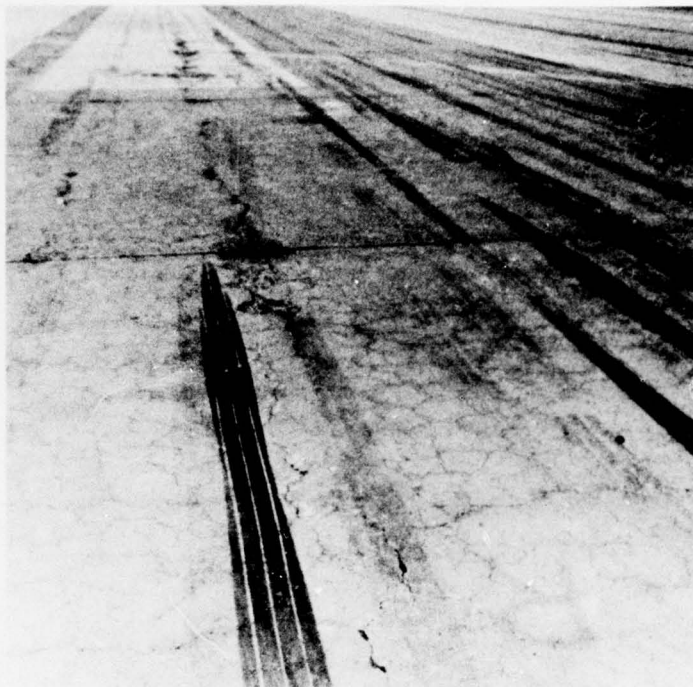
criteria for limited subgrade frost penetration design, and no reduction in the evaluations for frost condition operation is warranted (table 4). The runway interior pavement, however, is deficient by 3 in. in the thickness of the crushed-stone base course relative to current normal (nonfrost) heavy-load design criteria (265,000-lb gear loads). Similarly, the two taxiways are deficient by 1 in. in pavement thickness and by 4 in. in crushed-stone base course thickness. All of these pavements show some load-induced defects, principally shallow rutting and longitudinal cracking, as shown in photos 1 and 2. Rigid pavement slab thicknesses of primary pavements are also from 3 to 4 in. less than those required by current normal (nonfrost) heavy-load design criteria, and load-induced defects were noted in all of these features to degrees roughly proportional to exposure to traffic channelization (photo 5).

Photo 5. General view of PCC pavement at
SE end of runway

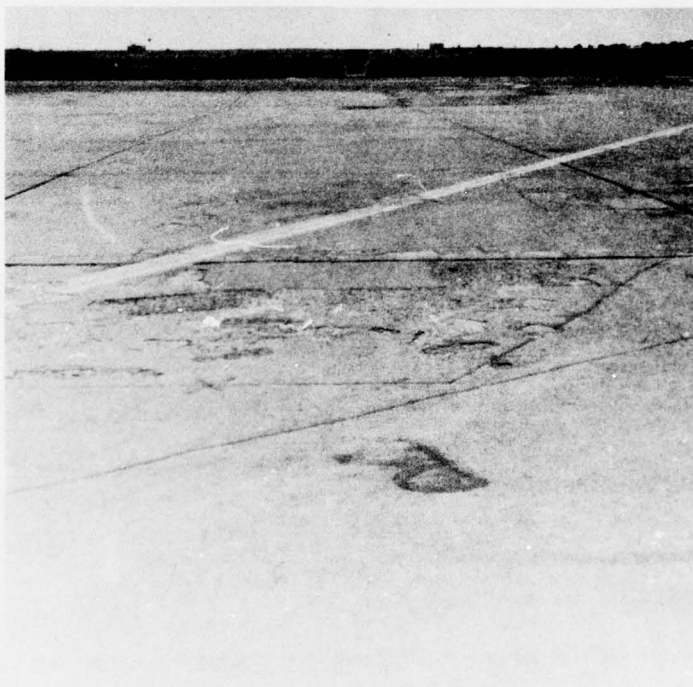
14. The north warm-up apron (feature A1B) was in very good condition based on the percentage of slabs containing no major defects. Jet blast had caused scaling on approximately 10 percent of the slabs. Photo 6 shows some of the scaling in feature A1B. The south warm-up apron (feature A2B) was in fair condition. There were 110 major defects in this feature, of which 100 were longitudinal cracks. Most of the longitudinal cracks were of the type shown in photo 7. They appeared to be caused by the manner in which the pavement had been placed rather than by overloading. Scaling was also prevalent in this feature, with approximately 20 percent of the slabs containing this defect (photo 8). Parking aprons A and B (features A3B and A4B) were in very good condition based on the percentages of slabs containing no major defects. Approximately 10 percent of the slabs in these features contained longitudinal cracks, which were the predominant defect. A large percentage of these longitudinal cracks were of the type shown in photo 9, and they did not appear to be load related. Considerable expansion of these aprons has resulted in upheaval of the shoulder pavements (photo 10) and the removal of the PCC pavement around embedded features, such as the fueling hydrants and drainage structures (photo 11).

Photo 6. Scaling of slabs in north warm-up apron

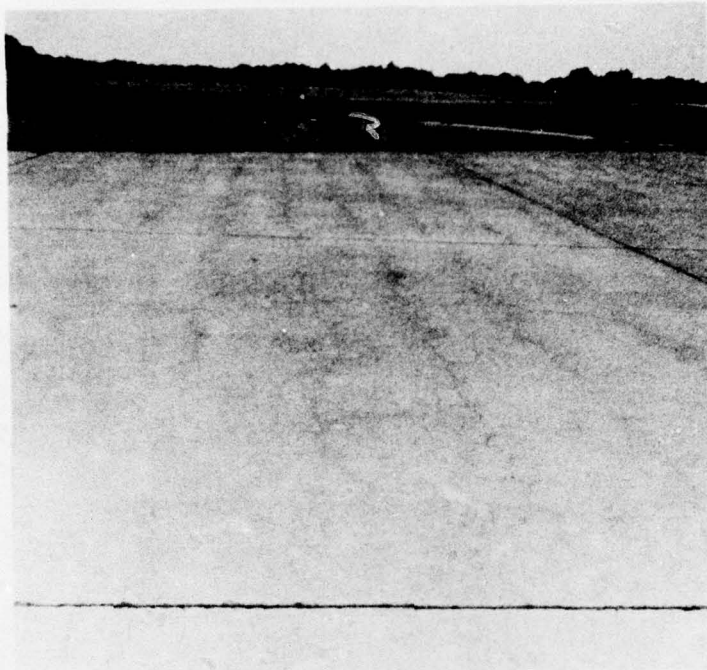
Photo 7. Longitudinal cracks in south
warm-up apron

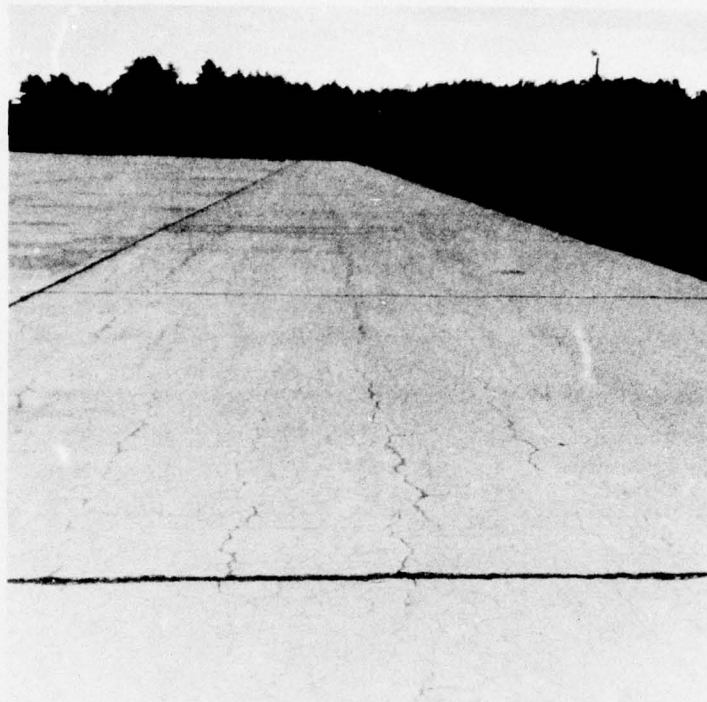
Photo 9. Typical longitudinal cracking
(as in parking aprons A and B)

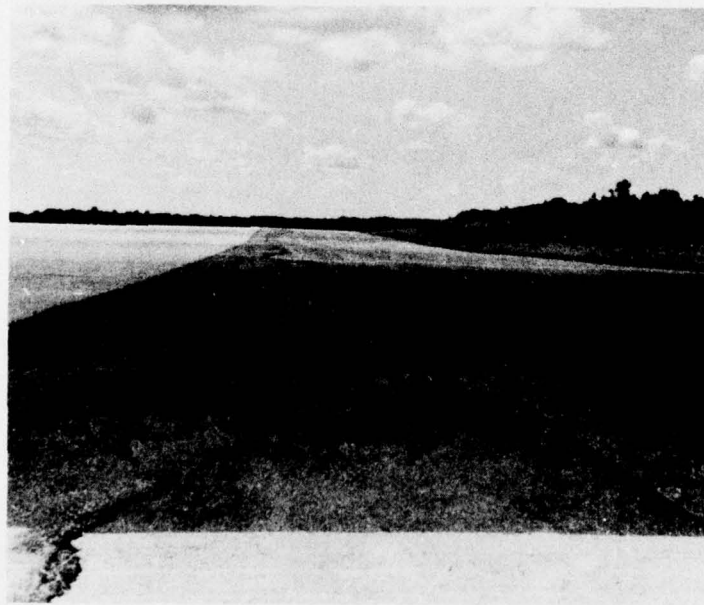
- d. Expansion of the PCC pavements of the aprons had caused upheaval of the shoulder pavements and displacement of drainage structures and fueling facilities. The PCC pavement around some of these facilities had been removed and replaced with AC pavement.
- e. Around some of the drainage structures, polyurethane foam was used to replace the PCC pavement.
- f. Spall repair has generally been accomplished by removing the damaged pavements and replacing them with new PCC.
- g. Evidence of detrimental effects of frost action was observed in only one area, the shoulder of taxiway D. (The water table in this area was within 5 ft of the pavement surface.)

Photo 10. Upheaval of shoulder pavement at
north end of parking apron A

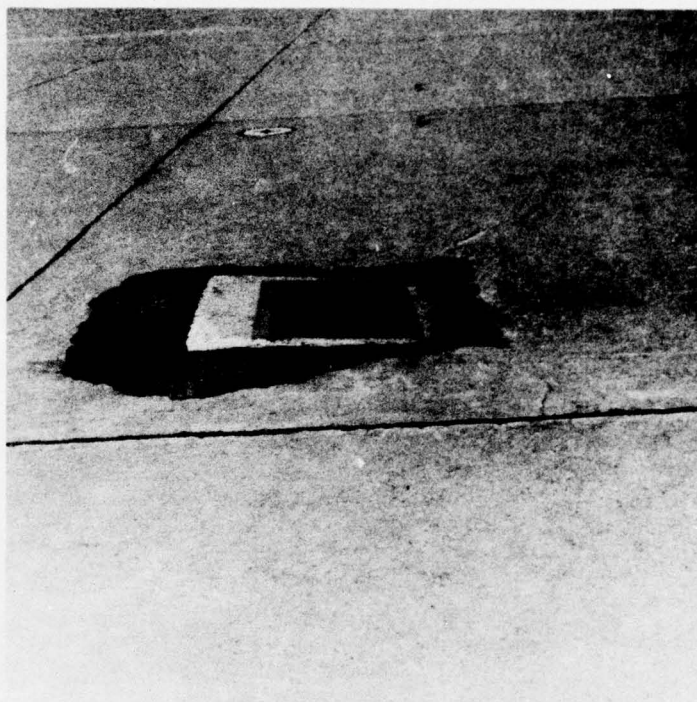
Photo 11. AC replacement of PCC pavement
at drainage structure

24. Maintenance of the airfield pavements at PAFB generally has consisted of seal coating the AC pavements and sealing joints and patching spalls in the PCC pavements. However, continued movement of the PCC pavements of the aprons due to horizontal expansion has caused an increase in the cost of maintenance. This type of movement necessitates the removal of the PCC pavements around an embedded feature and replacement with a flexible material such as the AC shown in photo 11. As an experiment, polyurethane foam has been recently used as a fill material between embedded features and the PCC pavements. A tabulation
